Lab Report XRF 443

Analysis of a Roman sword with the M4 TORNADO

This report describes the analysis of parts of a Roman sword. After removing the corrosion layers, the sword was analyzed with Bruker's μ -XRF spectrometer M4 TORNADO.

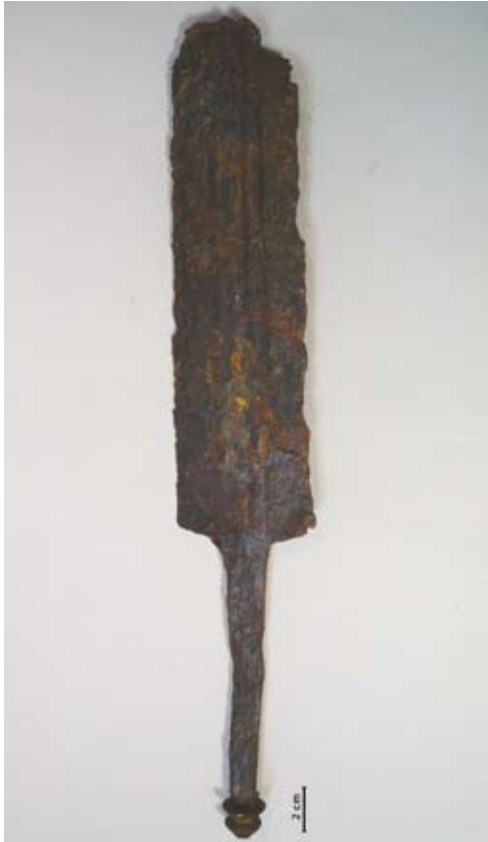
Analyzed object

Fig. 1 Image of the Roman sword showing the remaining corrosion patina after cleaning.

The examined object is a Roman sword of a type called Gladius (see Fig. 1). It was found in the north-east of Germany, close to the town of Pasewalk. Several manufacturing features indicate that the sword was not manufactured in this region. It was most likely carried by Germanic warriors,

who broke it and sacrificed it to the gods. The sword was highly corroded.

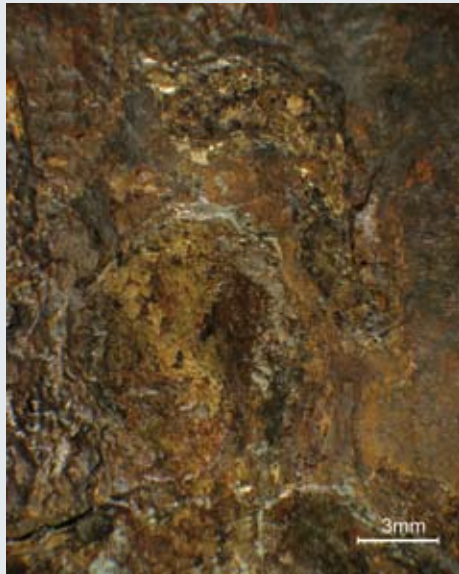
Inlaid work on the blade of the sword

Fig. 5 Picture showing the inlaid work on the blade of the sword
