RESIDUAL STRESS MEASUREMENT WITH GADDS MICRODIFFRACTION SYSTEM

Authors: Bob He & Uwe Preckwinkel

This is an example of residual stress measurement with GADDS Microdiffraction System. The residual stress on the inside surface of a spring was measured with Cr tube and 0.3mm collimator. Since the size of the spring is relatively small (coil diameter 10mm, wire diameter 1mm and coil pitch 4mm) the Laser Video Sample Alignment System was used to position the inside surface of the spring. The spring was made of precipitation hardenable stainless steel 17-7PH. The (211) diffraction ring of the alpha phase was used for stress measurement.

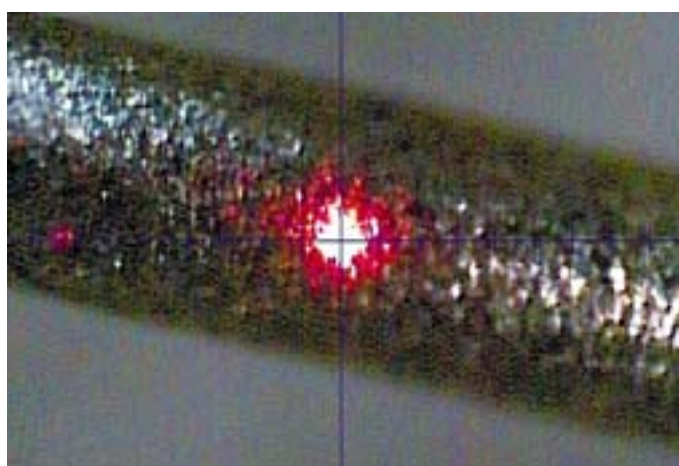
Figure 1: The image from the laser video sample alignment system.

Fig 1. shows the laser spot on the inside surface of the spring wire. When the laser spot is in the center of the crosshair the sample surface is aligned to the goniometer center.

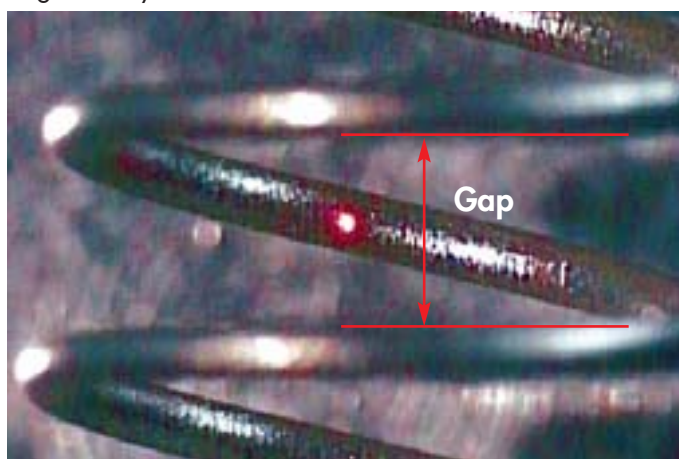
Figure 2: The video image showing a section of the spring. Both incident and diffracted beams can pass through the gap between the wires.

Fig 2. shows a part of the spring. The incident x-ray beam and diffracted beams can pass through the gap between spring wires so the residual stress can be measured nondestructively.

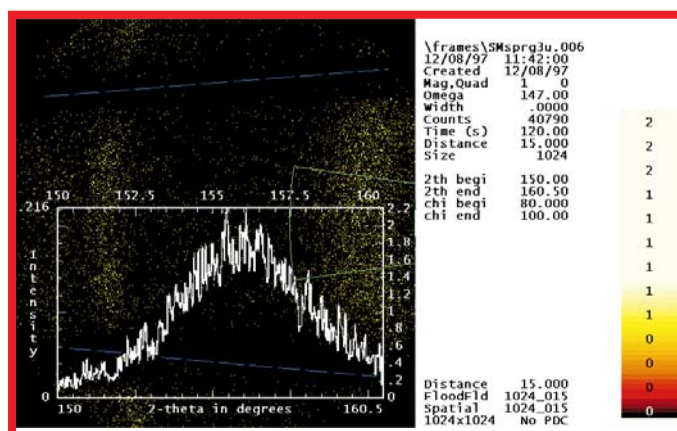
Figure 3. A measured frame with chi-integrated profile. The green broken line box defines the chi integration region. The blue broken lines indicate the shadow of the wires.

Fig 3. shows one of the measured frames with chi-integrated profile. The broken blue lines indicate the shadow of the wires. For data evaluation, the frames were first processed with the GADDS stress function and then imported to DIFFRAC^{plus} Stress software for stress analysis.
